# MI@NUS ASSET INTEGRITY & RISK MANAGEMENT R&D WORKSHOP 2014

## CURRENT DEVELOPMENTS IN MOORING INTEGRITY MANAGEMENT

**James Laybourn**

19th November 2014

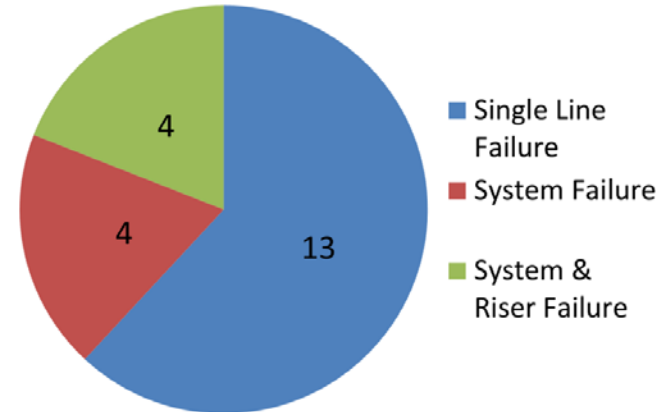
Mooring Failures 2001-2011

Actual mooring system failure probability ~30 times greater than Industry target

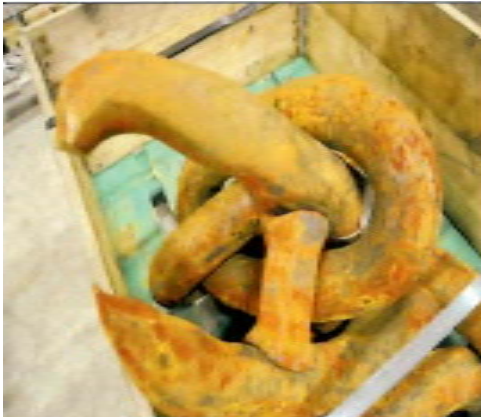
Overload (Deepsea Atlantic 2012)

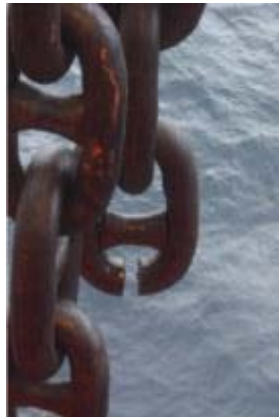
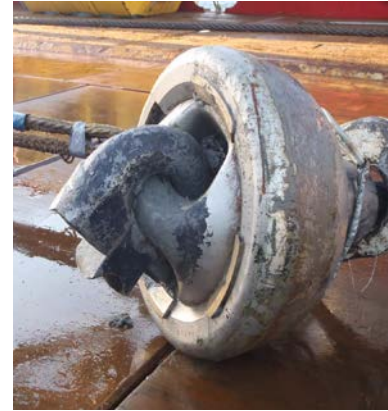
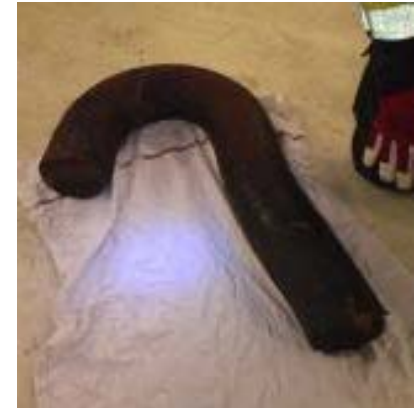
Fatigue (Transocean Spitsbergen 2012, Transocean Leader 2011, Norne 2012)

- Fatigue test data for large diameter R5 chain (e.g. TWI JIP in progress)
- Improved understanding of OPB impact on chain fatigue (e.g. SPM OPB JIP)
- Improved understanding of chain fatigue crack growth (e.g. Lassen, 2005)
- Improved FEA models of chain SCFs (e.g. Vargas, 2004)

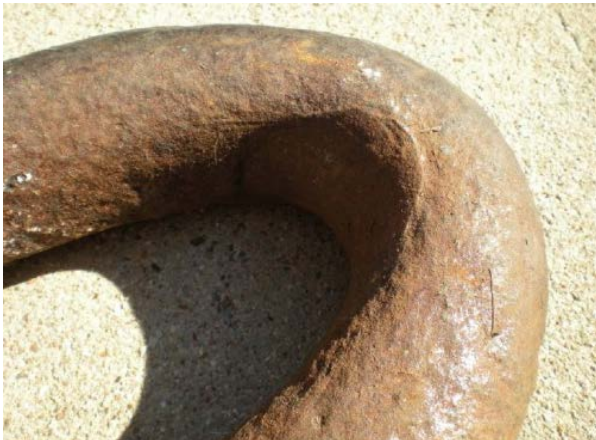
Heavy Narrow Wear (OTC 20613)

- Improved chain wear models (e.g. NDE MIM JIP)

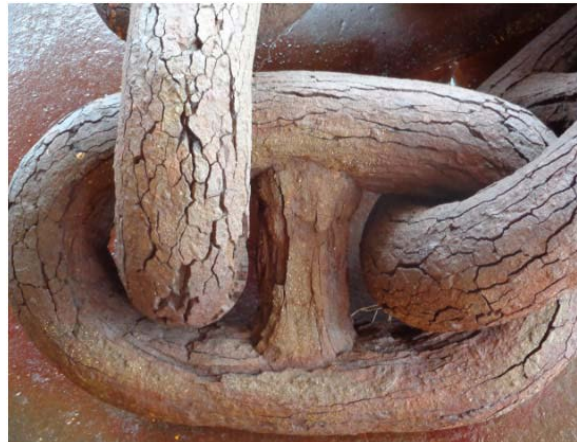
Corrosion (Africa)

- Improved chain and wire rope corrosion models (e.g. SCORCH JIP)
- Improved models of corroded chain residual strength (e.g. FEARS JIP in progress)
- Improved reliability models accounting for corrosion deterioration over time

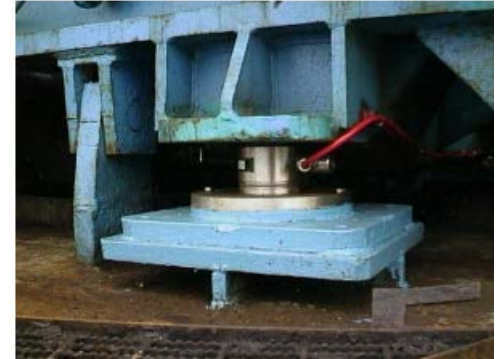
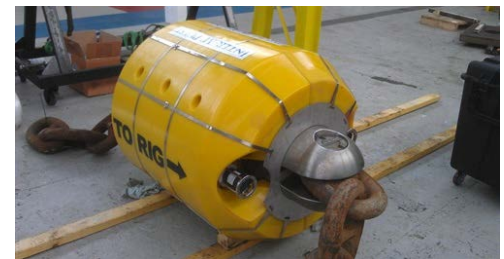
- Position Monitoring
  - DGPS can detect change of movement behaviour
- Tension Monitoring
  - Innovative instruments and acoustic data transmission have made long term line monitoring viable
  - Needed to monitor for failed line
  - Used to assess mooring performance
- Material Monitoring (under development!)
  - For long term monitoring of line corrosion

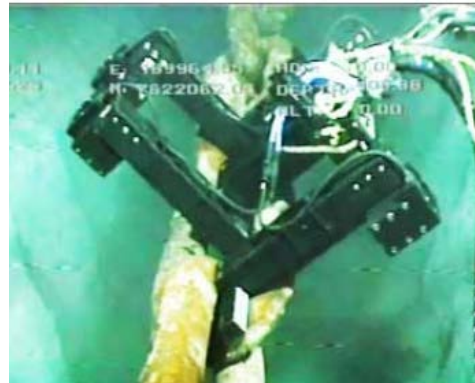
Optical Caliper  
(Welaptega CMS™)

- In-situ inspection of mooring line is difficult and costly
  - Most inspections are General Visual Inspections (GVI) made using ROV camera
- Some Specialised Inspection Techniques
  - Chain
    - Mechanical & optical calipers
    - Alternating Current Field Measurement (ACFM)
    - Under development
  - Rope
    - Optical
    - Magnetic
  - Connectors
    - 3D HD video
